USAAEFA PROJECT NO. 74-77 - Vol 1

ROTARY WING ICING SYMPOSIUM.

**SUMMARY REPORT.
VOLUME I,**

11
4 - 6 JUNE 1974

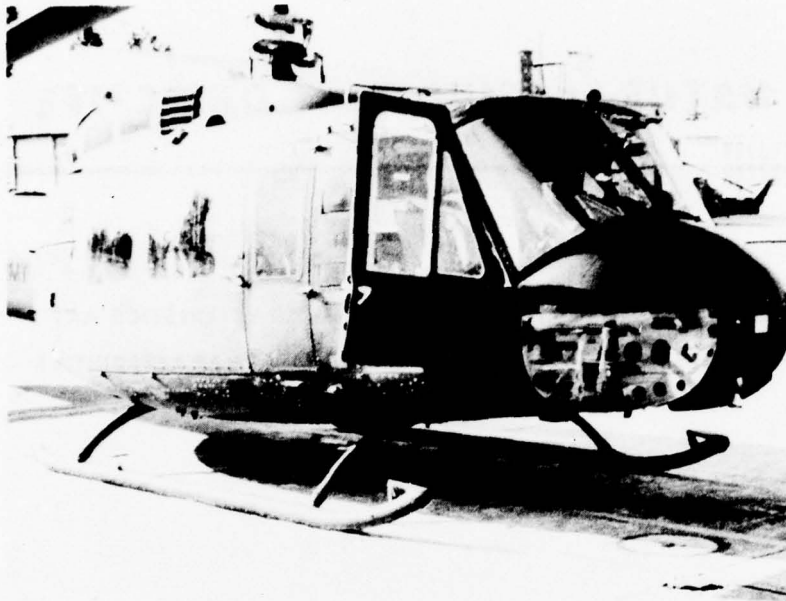
Slide 3. UH-1H Test Helicopter.

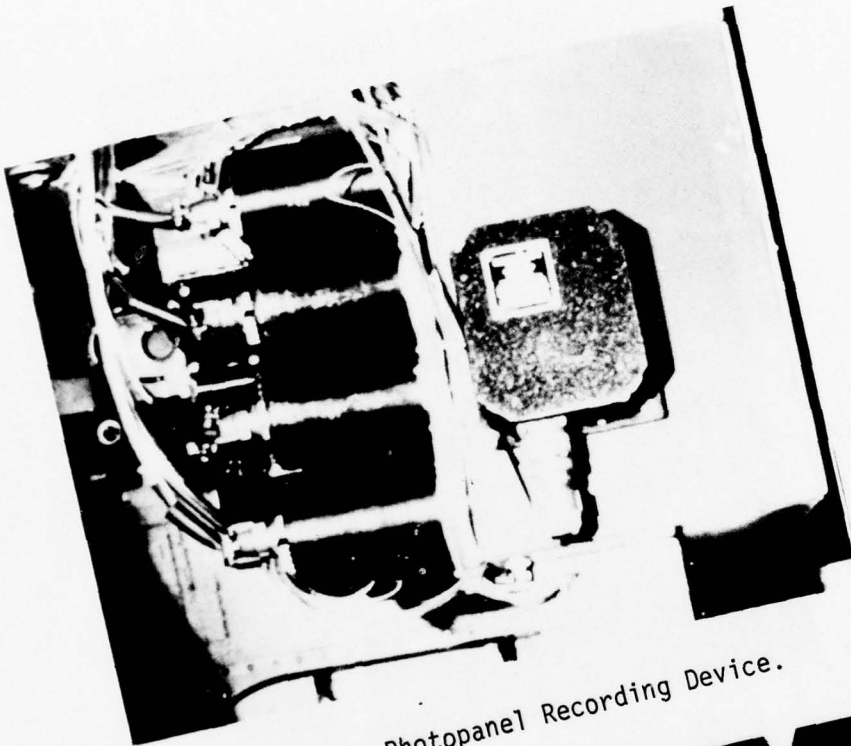
Slide 7. Photopanel Recording Device.

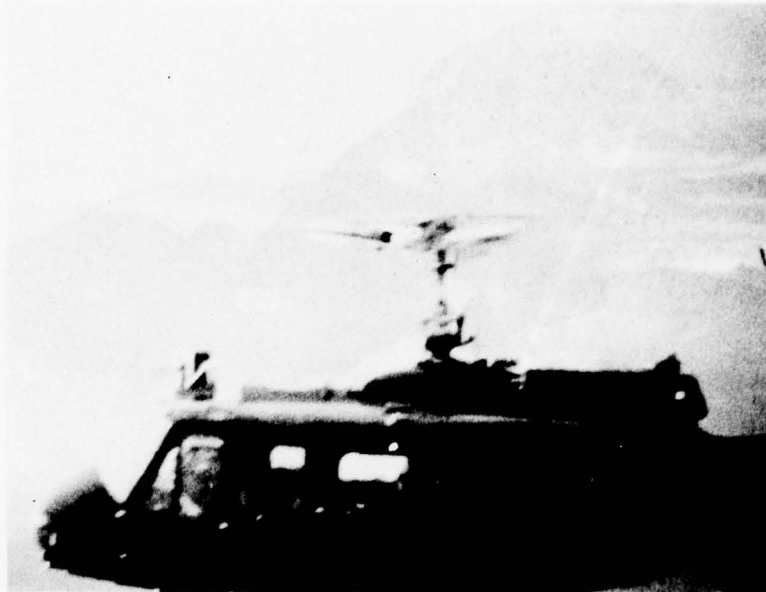
Slide 17. Engine Inlet Icing.

Various miscellaneous results were obtained during these tests and I would now like to cover these. It was found that post-icing in-flight photographs of the inlet area showed that significant amount of ice had accumulated on the left engine filter screen.

This characteristic was contrary to the results of Major Brewer's testing. In the slide you can see that approximately 50 percent of the screen is covered; however, there was no increase in engine exhaust gas temperature, nor was there any change in the measured engine inlet plenum differential static pressure when compared with the no-ice condition. These results would indicate that engine air inlet filter icing is less of a limiting factor than main rotor icing for the UH-1H helicopter (slide 17).

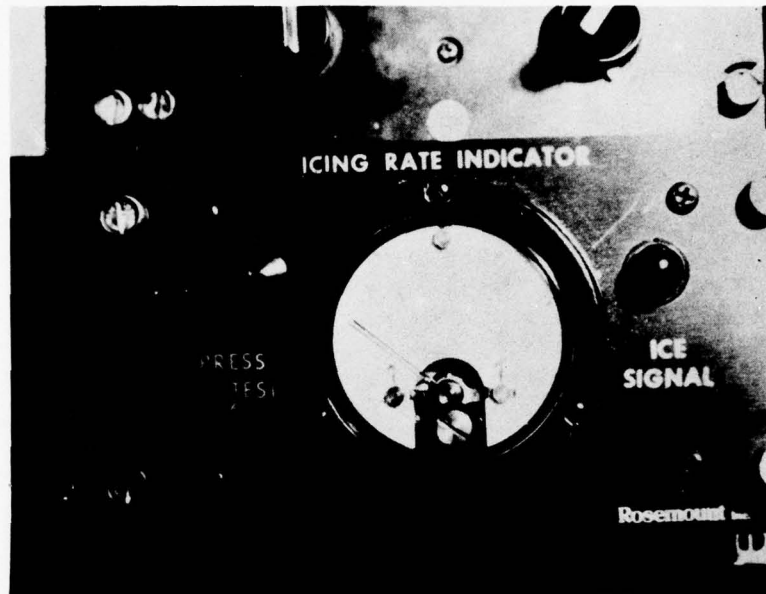
SLIDE 3. ROSEMOUNT ICING RATE METER.

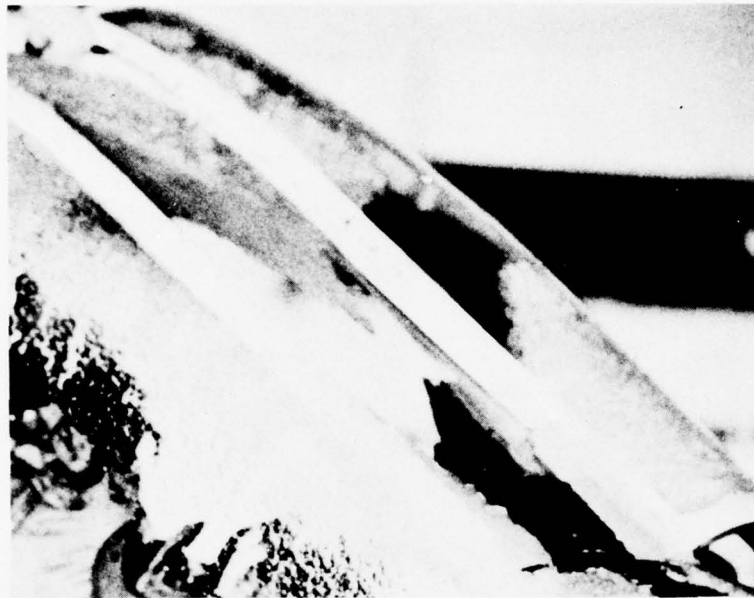
SLIDE 7. RUNBACK AND REFREEZING CAUSED RESTRICTED FIELD OF VIEW.

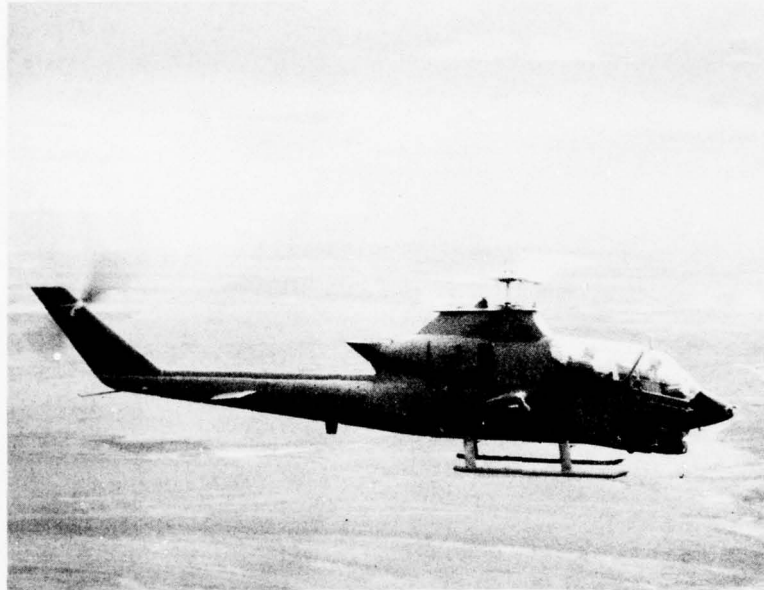
SLIDE 9. AH-1G WITH IR SUPPRESSOR TAILPIPE INSTALLATION

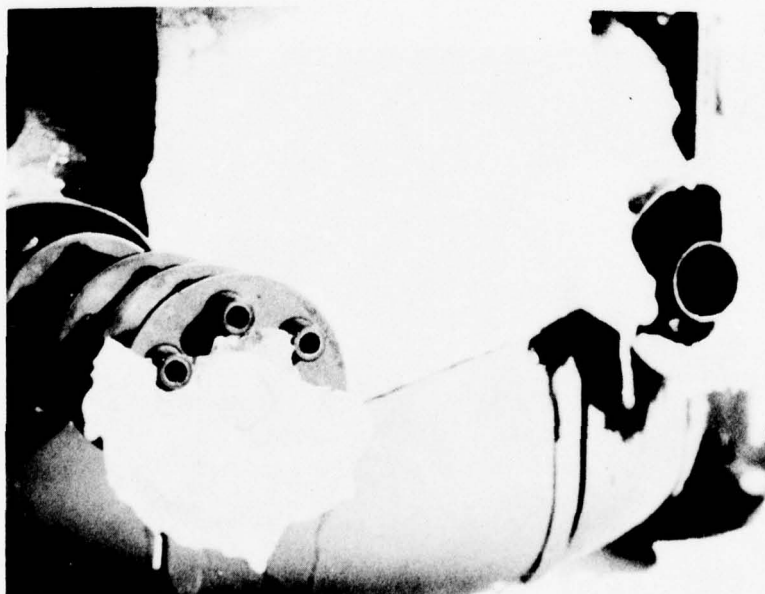
SLIDE 16. ICE REMOVED ON THE MINIGUN AFTER DRY FIRING.
